横断地盤線  
測点3+00.000

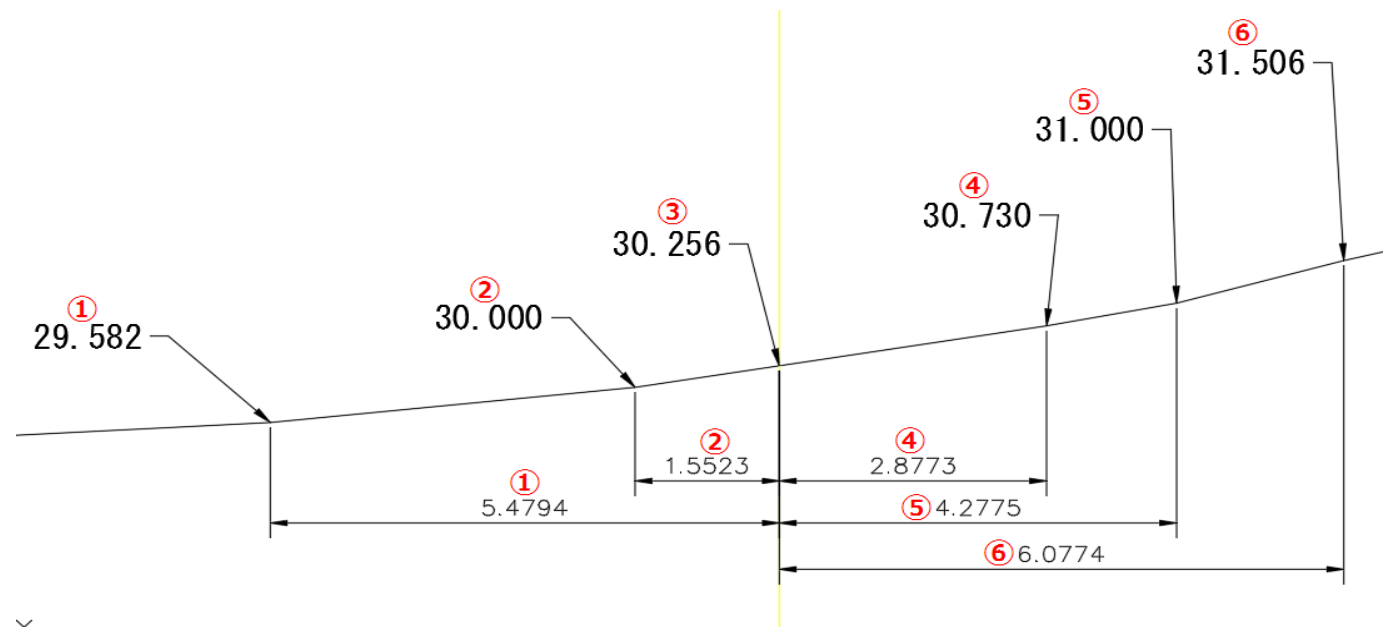
▽  
- <CrossSect name="0+60.00" sta="60.">  
- <CrossSectSurf name="現況地形16" desc="">  
 <PntList2D>-50. 28.110735518624 -47.684639010696  
 28.127101798054 -42.58650655155

28.114593675949 -42.176661757561  
 28.11434048762 -37.464320289079  
 28.123835307426 -19.845822833073  
 28.939096590291 -18.732663054614 29.  
 -18.698169140295 29.000513097121  
 -18.571407666329 29.001235212446  
 -18.298991000904 29.003776956062  
 -18.16154982891 29.004472334304  
 -18.004208885844 29.00631607445  
 -17.573503941727 29.006645963442  
 -17.248371356135 29.007402428901  
 -16.610015367192 29.010020223569  
 -16.040901478049 29.017712037873  
 -15.192003329913 29.026002859616  
 -11.478067255274 29.24999329451  
 ① -5.479367543354 29.582498408086  
 ② -1.55233649787 29.999999999998  
 ③ 0.000000000024 30.255997899867  
 ④ 2.877263366989 30.730491271835  
 ⑤ 4.277502538801 31.000000000004  
 ⑥ 6.077411885707 31.505856722251

7.98852340122 31.971995514342  
 8.078733999276 31.994293595975  
 8.110679098425 31.999999999999
